This mast stump socket shows the problem.

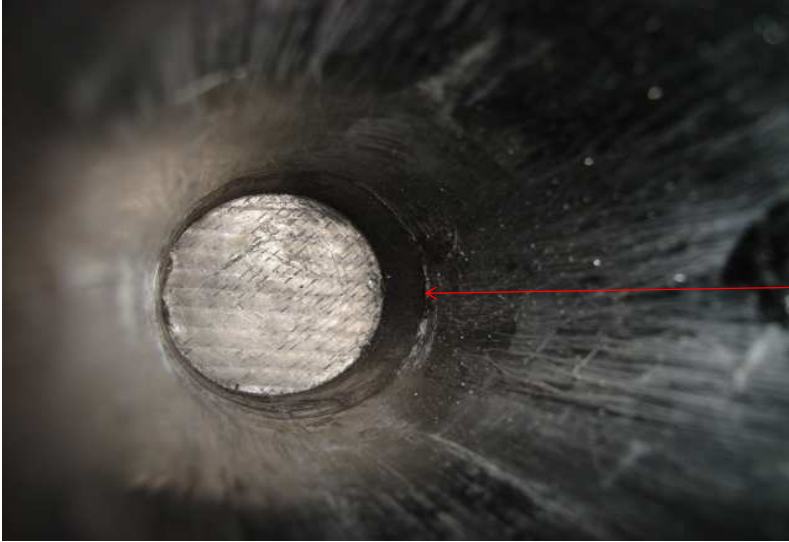
The Carbon disc should be glued into the tube, support on the small lip as seen here.

In this boat the disc was not properly glued and had been pushed down past the lip.

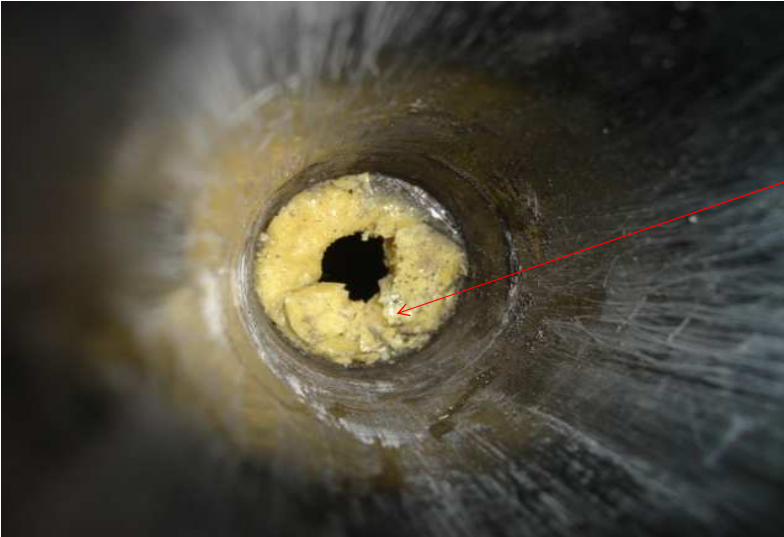
The disc was removed, revealing a large section of glue that should have been bonding the disc to the wall of the tube.
