This mast stump socket shows the problem.

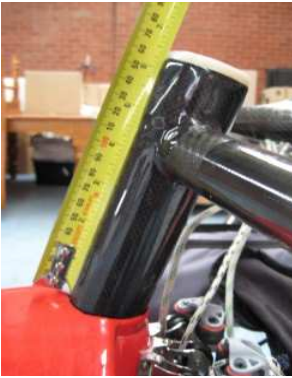
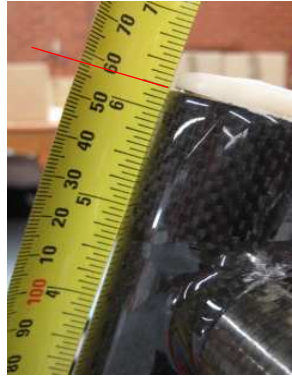
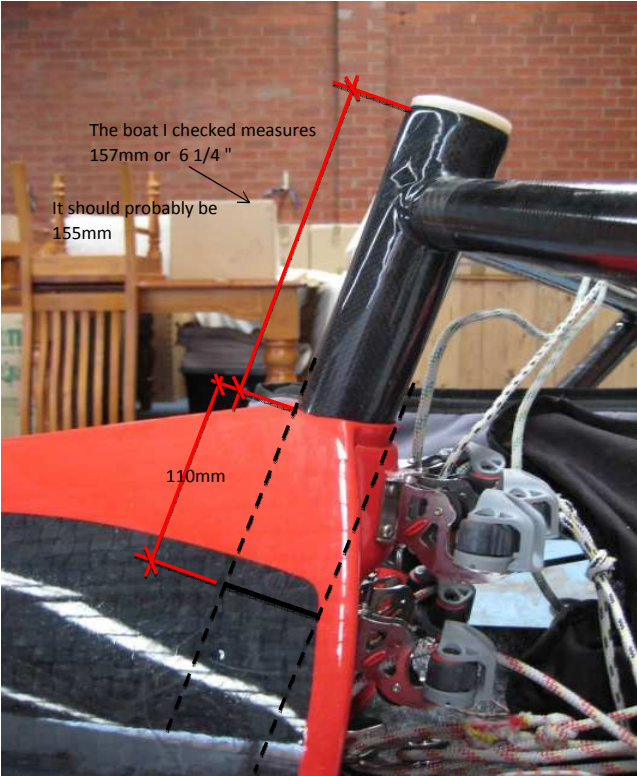
The Carbon disc should be glued into the tube, support on the small lip as seen here.

In this boat the disc was not properly glued and had been pushed down past the lip.
